# Repair Request #7948

| Campus | WPB South |

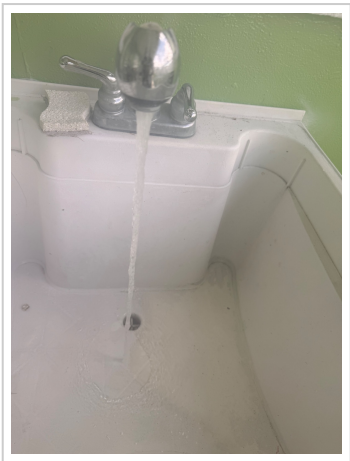
Original Photo 1

| Description | El sink donde de afuera donde se lava el mop esta roto y cuando se abre el agua esta gotenado por debajo , es de plastico , no estoy segura si debe swr reparadp o debe ser cambiaido. gracias |
